Certified Record of Proceedings

Structural Condition Inspection and Site Analysis of:

757, 765, 771, 777, 783, 791, & 793 Busti Avenue, Buffalo New York

March 26, 2009

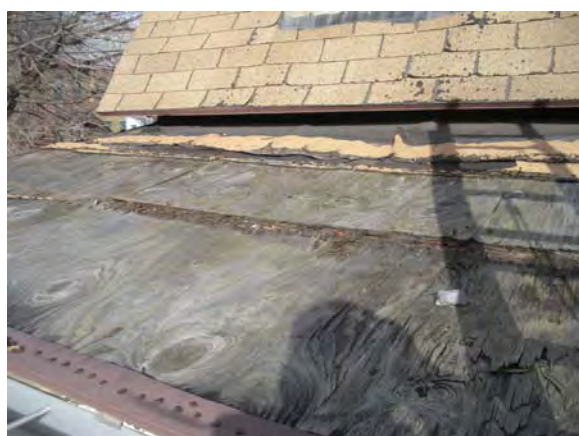
This building consists of two separate roof lines. The 2-story portion of the building consists of a gable roof oriented east-to-west. The single story portion of the building consists of a gable roof oriented north-to-south. On the west side of the single story wing are two gabled windows and a flattened section of the roof. The roofing on the two gabled roofs consists of three tab asphalt shingles. The shingles are in poor condition with several noticeable areas of cracked, deteriorated, or missing shingles on the north and south sides of the main building as shown in photographs 757-2 and 757-5. There is evidence of water leaking into the building on the west side of the north wing where it adjoins to the main building as shown in photograph 757-6. The flat section of the roof located west of the north wing is missing all the roofing material and the roof deck is rotted. Photograph 757-7 and 757-8 below shows the flat roof, the missing roofing material and the rotted roof deck.

Photograph 757-8: Flatted section of roof to the west of the north wing gable roof

the entire structure should be replaced to prevent water from leaking into the interior space and further deteriorating the structure. The decking to the flatted roof of the section west of the north wing should be replaced to prevent roof collapse. To keep the foundation stable, all basement openings, especially the exterior basement entrance door, should be resealed to minimize any further water infiltration into the basement. All broken windows should be boarded up to further prevent moisture infiltration in the interior building space.

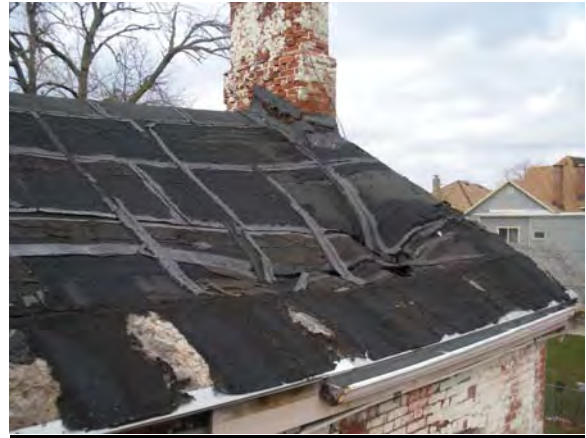
The roof of the main structure is a modified hip with a flattened section at the very top. The south wing is a half hip and the east wing is a gable roof oriented east-to-west. There are flat roofs over the back pantry and rear stairway and consequently both flat roofs have collapsed into the structure and are inaccessible for inspection. The remaining roofs could not be safely accessed for inspection based on the condition of the roof deck. The south wing, shown in photograph 771-6 below, has signs of sagging roof framing likely due to moisture infiltrating through the deteriorated roofing. Previous inspections of this property indicate the sloped portions of the roofs consist of three tab asphalt shingles which transition to 90 lb mineral coated roll roofing over the cornice area and flat areas. All the roofs that were stable are now in very poor condition as shown in photographs 771-5 through 771-8 below.

Photograph 771-6: South face of the east wing gabled roof

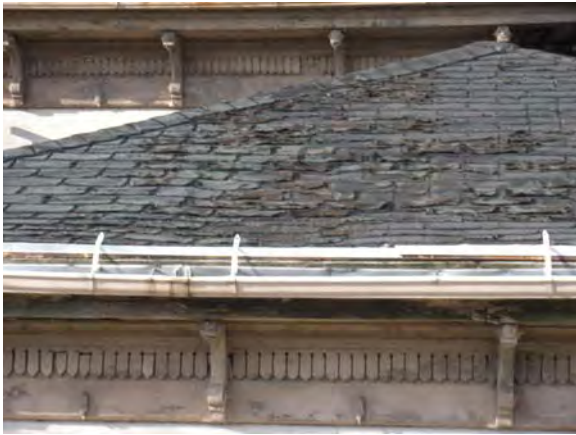
Photograph 771-7: South face of south wing half hip roof

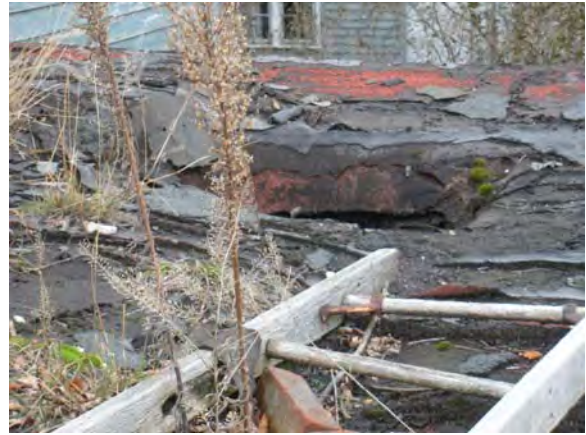
Photograph 771-8: Collapsed flattened roof over the rear pantry

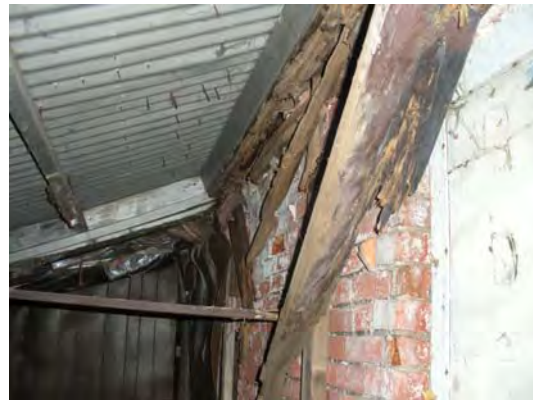
Photograph 771-10

The interior walls consist of rough sawn 2x4 stud construction with a lath and plaster wall and ceiling finish. The finish floors are a combination of carpet, linoleum and finish hardwood. There continues to be deficiencies in the plaster from water infiltration and damaging the plaster covering throughout the interior of the building. Photographs 771-9 through 771-12 below show the various holes in the ceilings and roofs in the accessible rooms of the east wing. Shown in these photos are obvious signs of moisture infiltration and severely damaged structural framing.

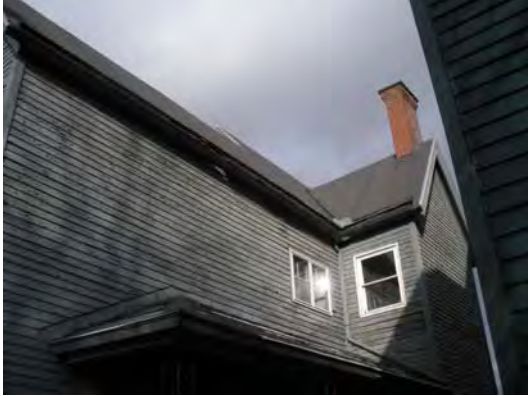
This building consists of a gable roof oriented east-to-west with a gabled section oriented north-to-south. The entire roof area consists of rolled mineral roofing placed over three tab asphalt shingles as shown on photographs 777-3 and 777-4 below.

Photograph 777-3: - South side of roof

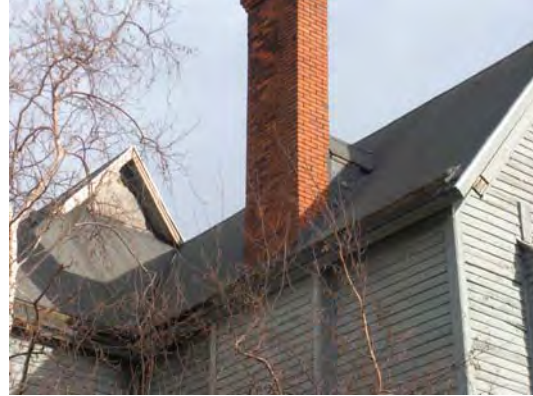
Photograph 777-4: - North side of roof

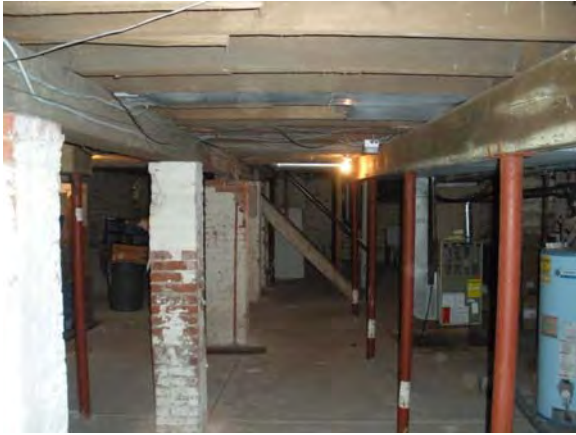
In the western 1/3 of the building, the floor joists are supported by additional 2x10's bearing on lally columns. There is one triple 2x10 support beam located 5'-8" from the north wall and another triple 2x10 support beam located 4'-4" from the south wall. Both beams cut the first floor joists clear span in half. Similarly, in the eastern 1/3 of the building, the floor joists are supported by one triple 2x10 beam that bears on lally columns. This beam is also located 5'-8" from the north wall. The floor joists and subfloor are in good condition with no structural defects visible. Photographs 783-5 and 783-6 below show the additional triple 2x10 beams placed under the first story floor joists.

Photograph 783-5: Triple 2x10 support beam located off of the north wall

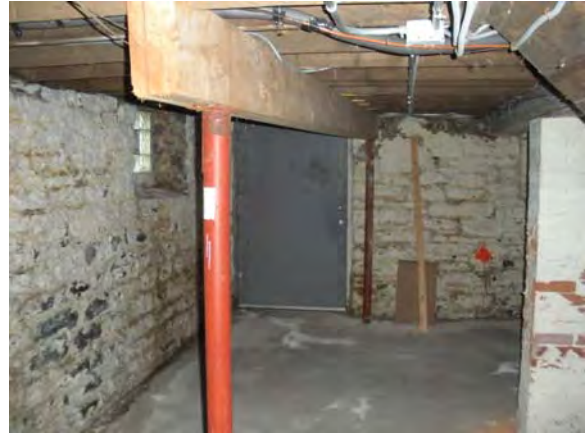
Photograph 783-6: Triple 2x10 support beam located off of the south wall

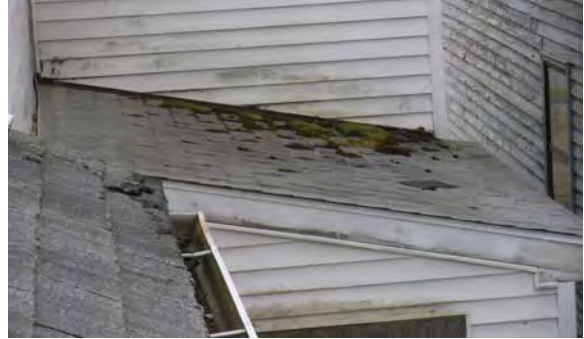
This building has a gable roof oriented east-to-west over the main structure and the 1-story addition. The roofing material on the two roofs are three tab asphalt shingles. The shingles on the main roof of the building are in good condition with no deficiencies. The shingles on the roof over the 1-story eastern portion of the building are in poor condition. There are several areas of cracked and deteriorated shingle tabs as shown in photographs 791-4 and 791-5 below.

Photograph 791-5: North roof section at the eastern end of the building.

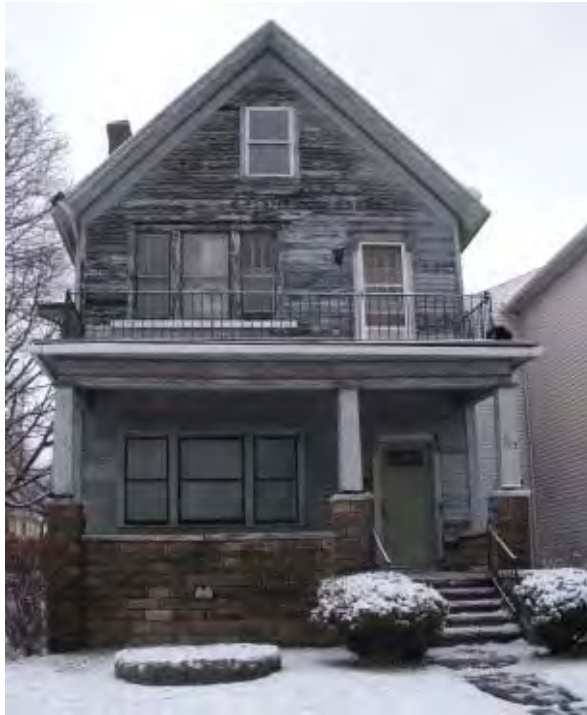
Photograph 793-1: West Elevation

The exterior siding consists of weathered cedar clapboards with visible signs of wear and deterioration. Several areas of the siding are missing and the exterior sheathing visible. Photographs 793-17, 793-18 and photographs 793-1 through 793-3 show the areas of siding that is weathered, deteriorated, or missing.

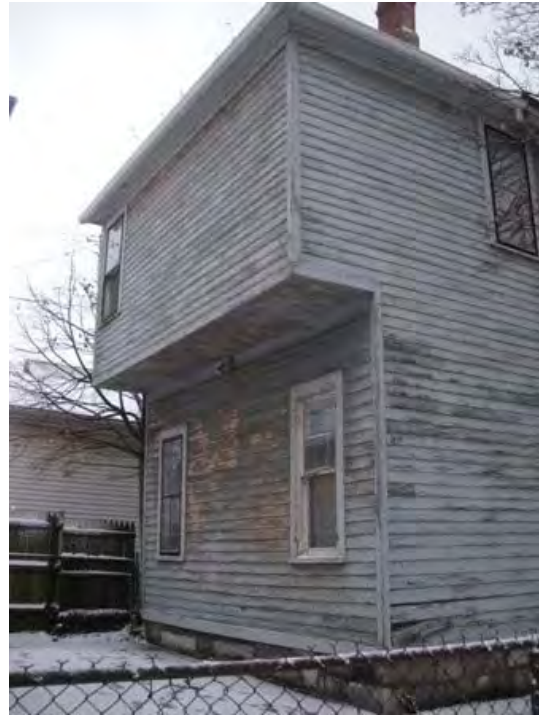
Photograph 793-2: East Elevation

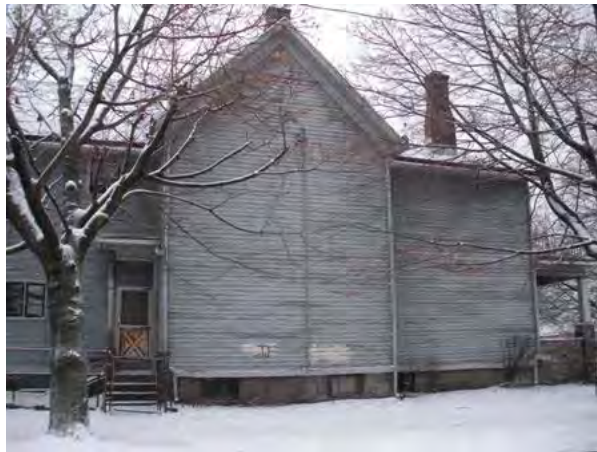
Photograph 793-3: North Elevation

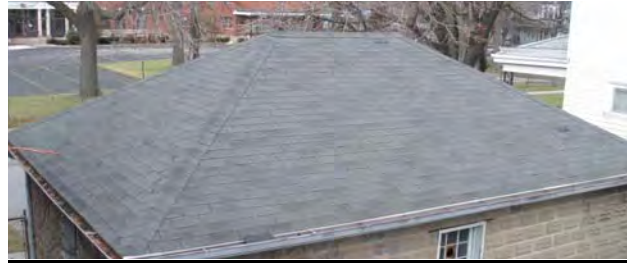
This building has a gable roof oriented east-to-west, a gabled roof section oriented north-to-south and a half hip roof section over the eastern end of the building. The roofing over the entire structure consists of three tab asphalt shingles. The shingles are in poor condition with several noticeable areas of cracked and deteriorated tabs. There are also several areas where shingles are missing on the north and south sides of the main building as shown in photographs 793-4 through 793-8 below. On the eastern end of the property is a detached 3-bay garage with a modified hip roof as shown in photographs 793-9 and 793-10. The roof of the garage is in good condition with no visible signs of shingle deterioration.

Photograph 793-9: South and east face garage roof

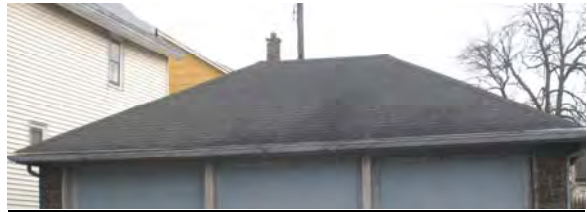
Photograph 793-10: North face of garage roof

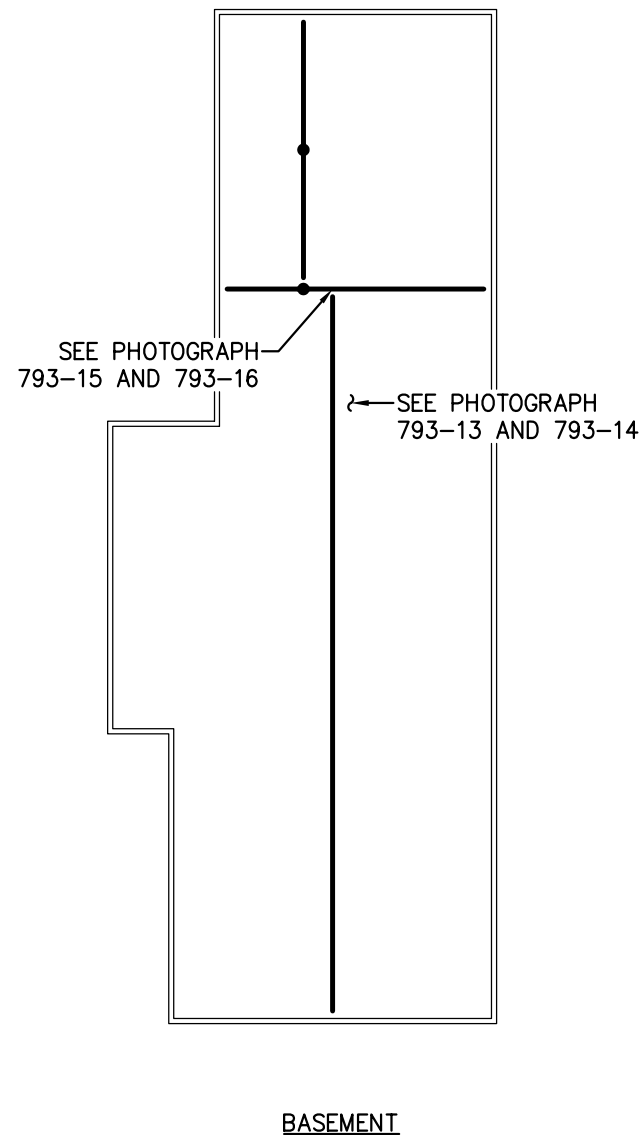
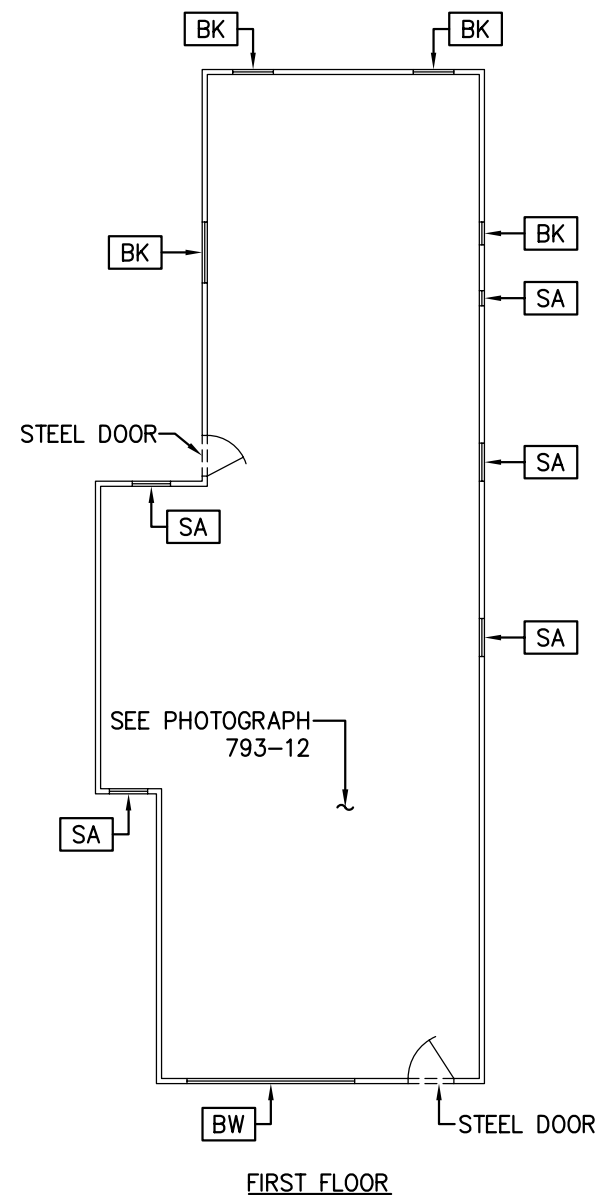
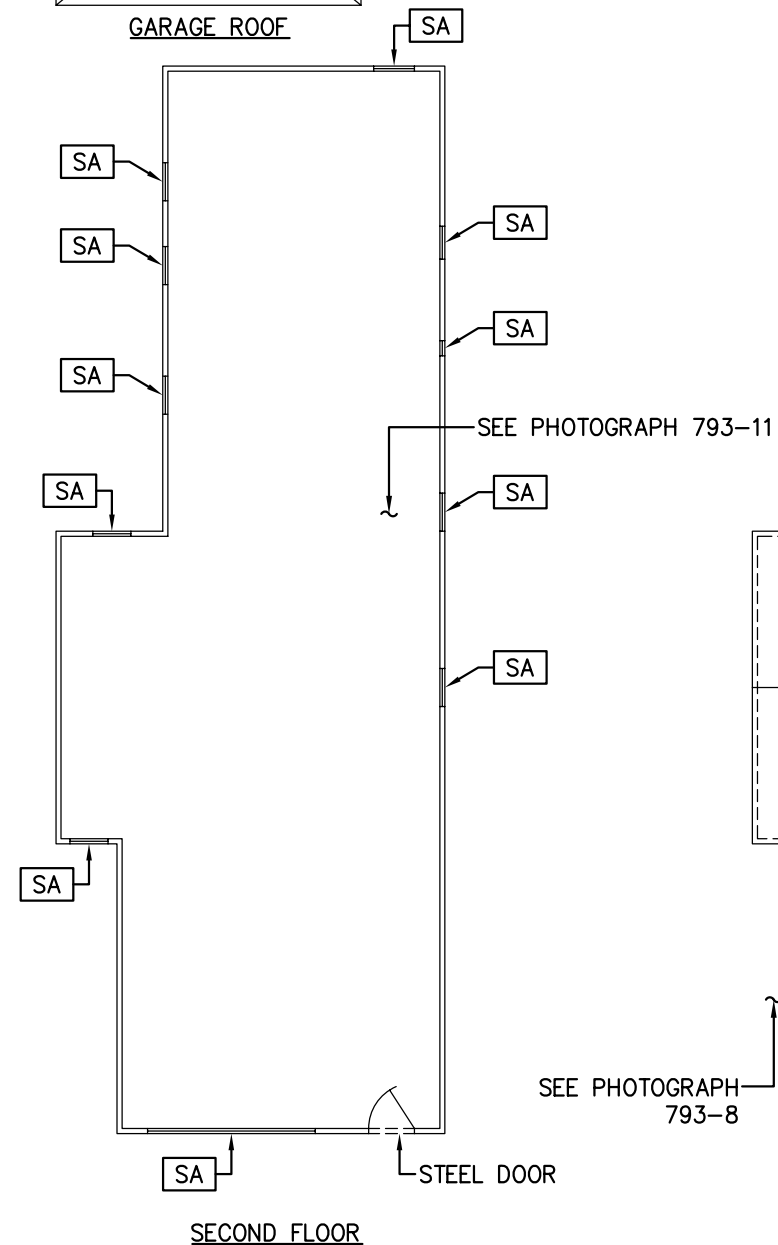
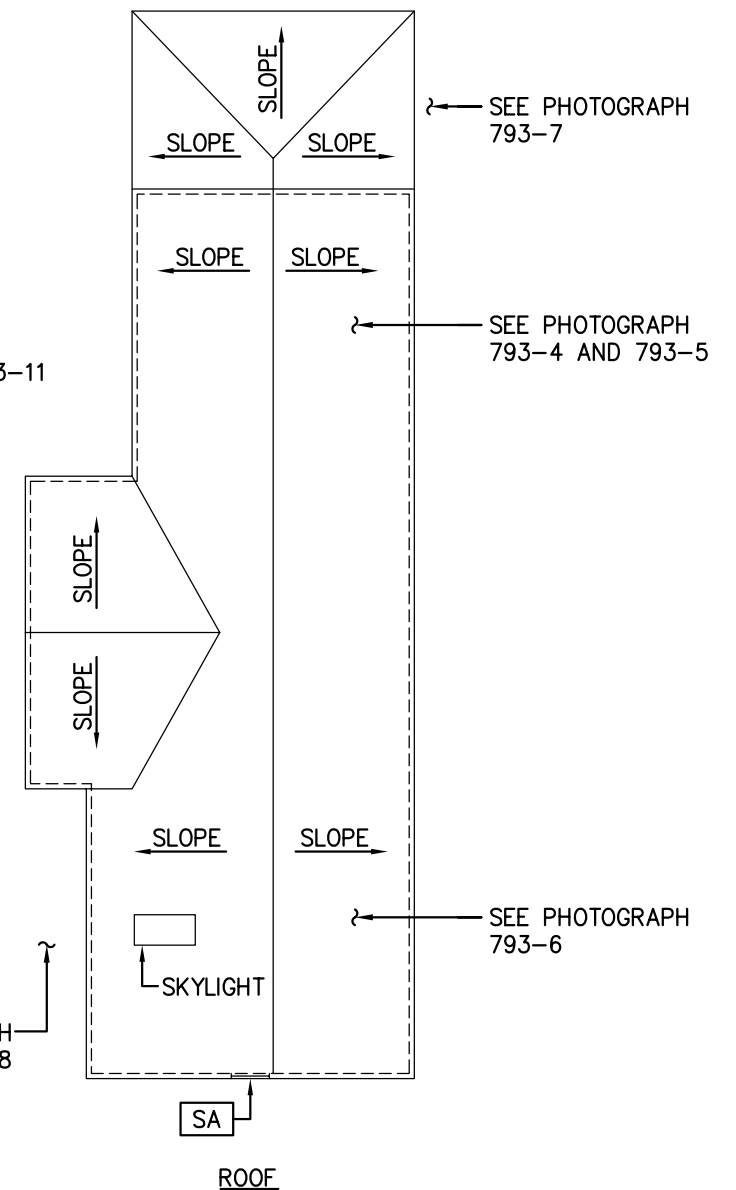
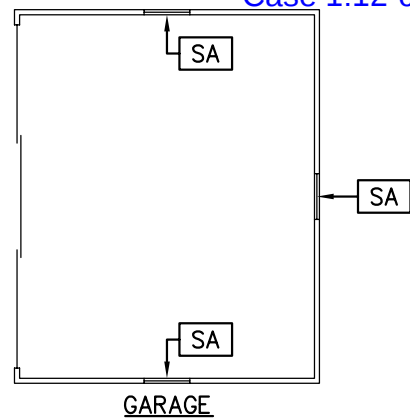
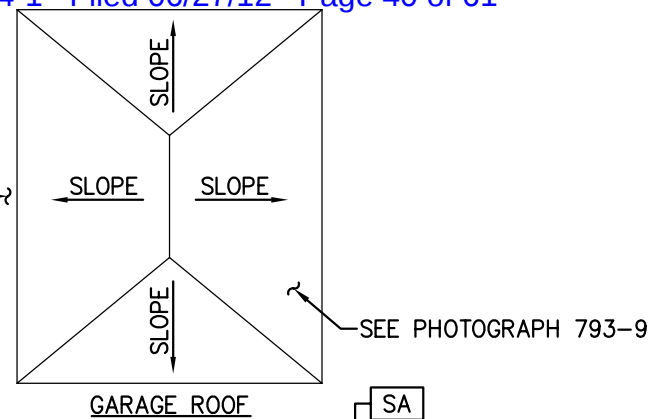
793 BUSTI AVENUE
SCALE: 3/32"=1'-0"

The exterior doors and windows were visually inspected for weather tightness. The condition of all the windows is shown in Drawing S-793.

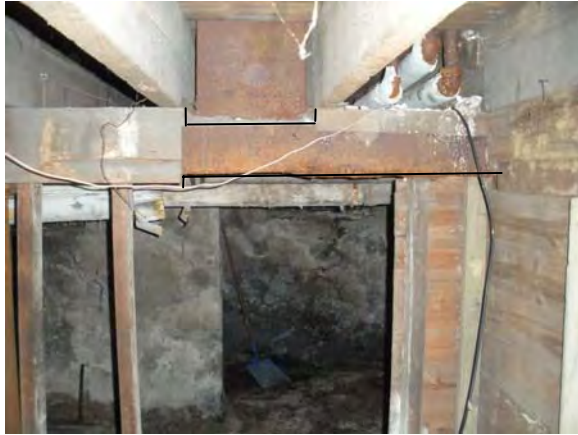
The center timber support beams are supported by 12x12 inch masonry piers and by the east and west end foundation walls. Approximately 20 ft from the western foundation wall, the a section of the center support beam has a noticeable 1½ inch thick by 4½ foot long notch from the bottom and a 2 inch thick by 14 inch long notch from the top missing from the beam. Photographs 793-13 and 793-14 display the top and bottom notch removed from the center beam.

Photograph 793-13: Notched center support beam

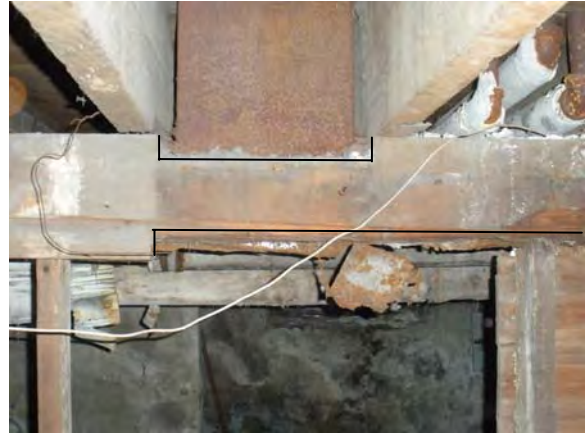
Photograph 793-14: Close up view of notched center support beam
